# CONSERVATION HIGHLIGHTS

Cayuga County Soil & Water Conservation District

Volume 11, Issue 4  
WINTER 2005

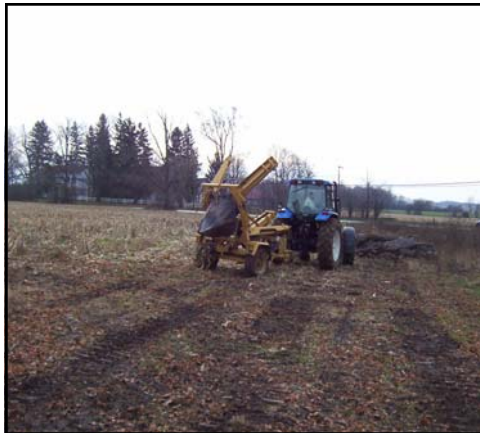
◀ Left & Below ▼ :

**BOCES** — The Cayuga County SWCD is busy working at the new Cayuga-Onondaga BOCES site located in Aurelius. The picture to the left shows the tree spade removing and replanting trees. The picture below shows District equipment loading soil stockpiles excavated from the foundation of the new building.

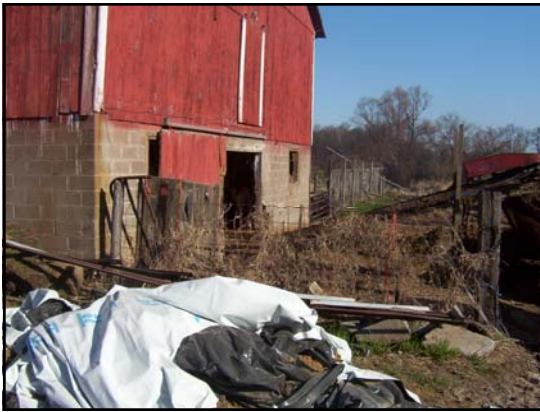
◀ LEFT

At the DeWall farm on Mentz Church Road, many improvements were made. The before picture on the left shows how the manure was being pushed directly out of the barn and into a dirt area for loading into the spreader. A stream, which is a tributary to Seneca River, is approximately 70 feet from the end of this barn. Also a pipe from the milkhouse was flowing directly into the tributary.

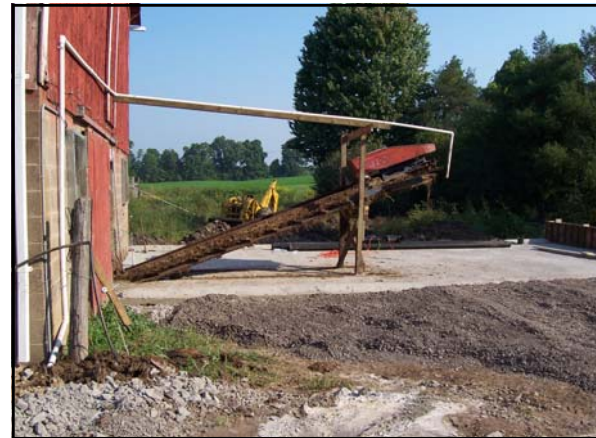
RIGHT ▶

In the after picture you see the improvement of a new manure concrete loading pad area with curbing to prevent the flow of manure into the adjacent tributary. A new milkhouse waste storage tank was installed and the milkhouse waste is now collected and pumped into the manure spreader on a daily basis and is dispersed through their daily manure spreading. A road drainage system and gutters have also been installed to prevent the runoff from the road and roof from flowing over this area.

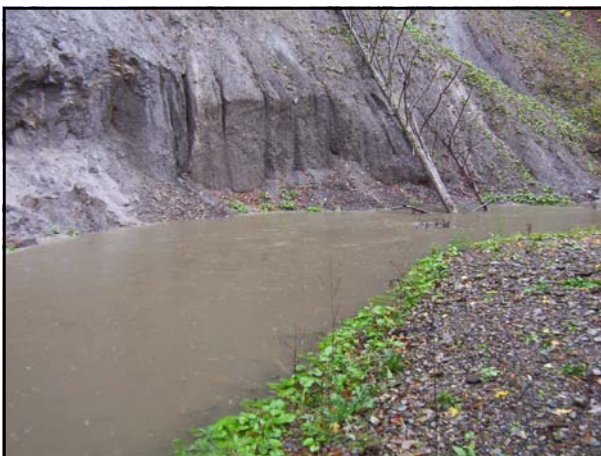
Below ▼

The picture below is showing the eroded *Valley Wall* on the Owasco Inlet.

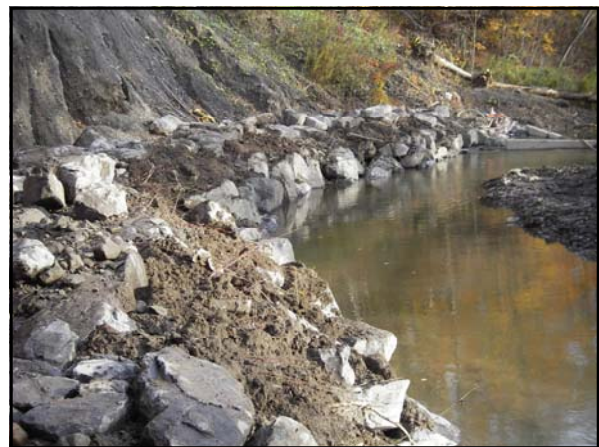
▲ Above

The picture above shows the *Vegetative Buttress* that was installed to stabilize the toe of the wall and reduce erosion. The buttress was constructed using alternative layers of rip-rap stone and soil and then planted with 2,000 trees and shrubs that will provide additional stability and shade over the water.
