# **LAKE COMO**

## **State of the Lake Report & Watershed Management Plan**

**September 2007**

**Cayuga County Department of Planning and Economic Development,  
Cayuga County Soil & Water Conservation District  
&  
The Lake Como Association**

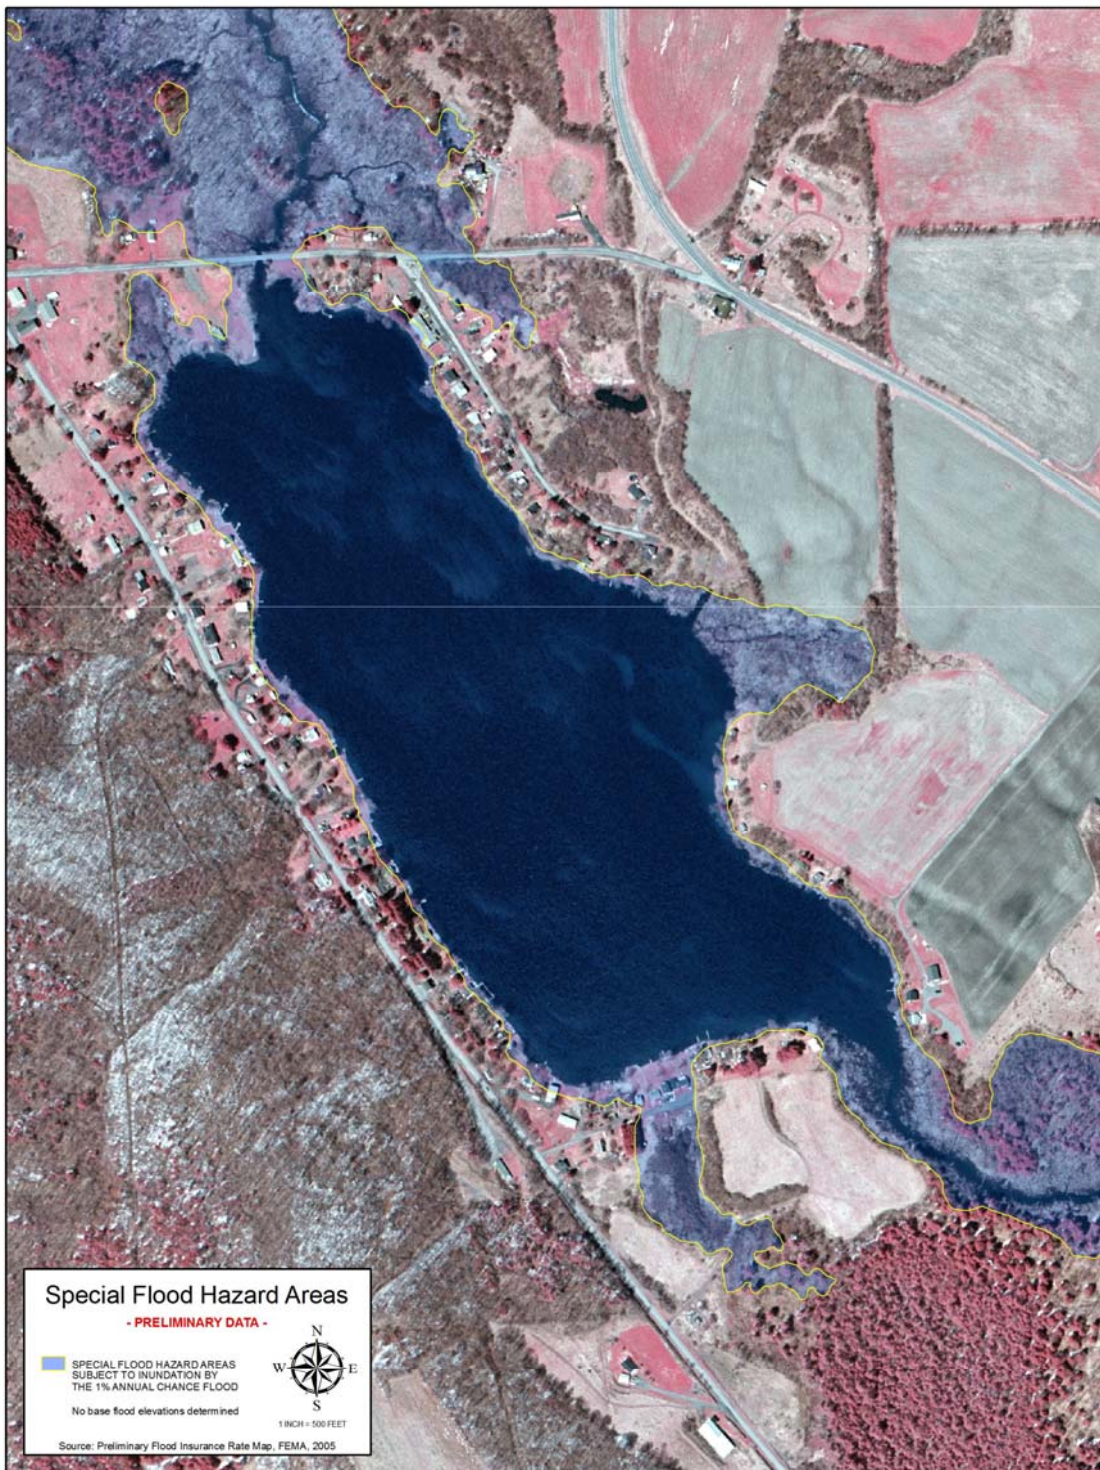
Figure 4: Special Flood Hazard Areas from the Preliminary Flood Insurance Rate Maps (FEMA, 2005)

The preliminary Flood Insurance Rate Map from FEMA (2005) shown in Figure 4 shows that there are houses located in the special flood hazard areas that are subject to the 1% annual chance flood.
